Manhole Inspection Summary

Manhole # S41CC_050MH

Insp Date: **12/6/07 1:43 PM**

Location Address: **940 e.eden**

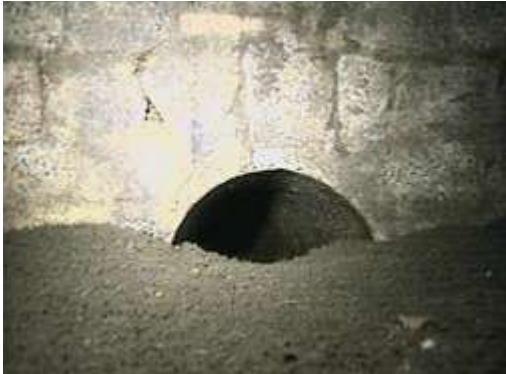
Defect 2

Condition: ☐ Sound ☐ Cracked ☐ Root Intrusion ☐ Deteriorated ☐ Leaks ☒ **Debris**

channel cond debris

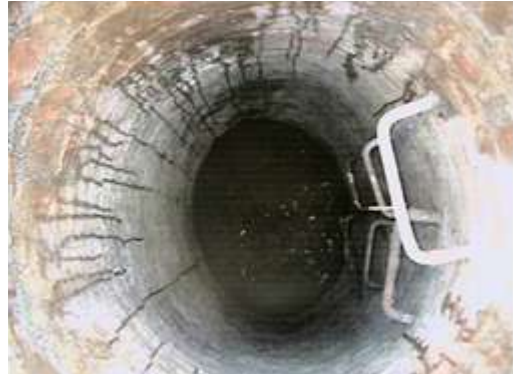
Defect 1

Infiltration: ☐ None ☐ Joint ☐ Cracks ☐ Mortar ☐ Roots ☒ **Wall**

☒ **Corroded**

corroded steps, infiltration from corbel wall

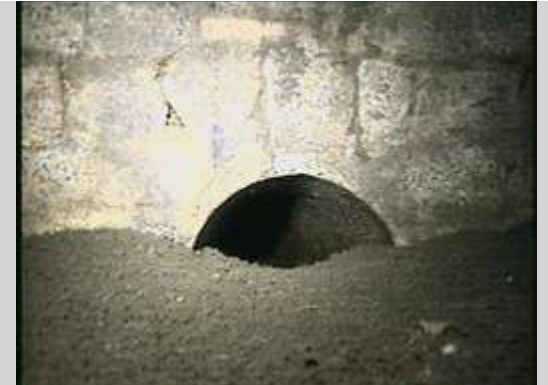
12 O'Clock Outflow

8 in. Circular Gravity Sewer
Pipe Out @ 12 O'Clock

Deposits: ☐ None ☒ **Mud** ☐ Sludge ☐ Debris ☐ Grease

Silt Depth: 5 (in.) Deposits Extent: **Heavy**
